NATIONAL TRANSPORTATION SAFETY BOARD
Investigative Hearing

Amtrak Passenger Train 501 Derailment
DuPont, Washington
December 18, 2017

RRD18MR001

Crashworthiness and Survival Factors

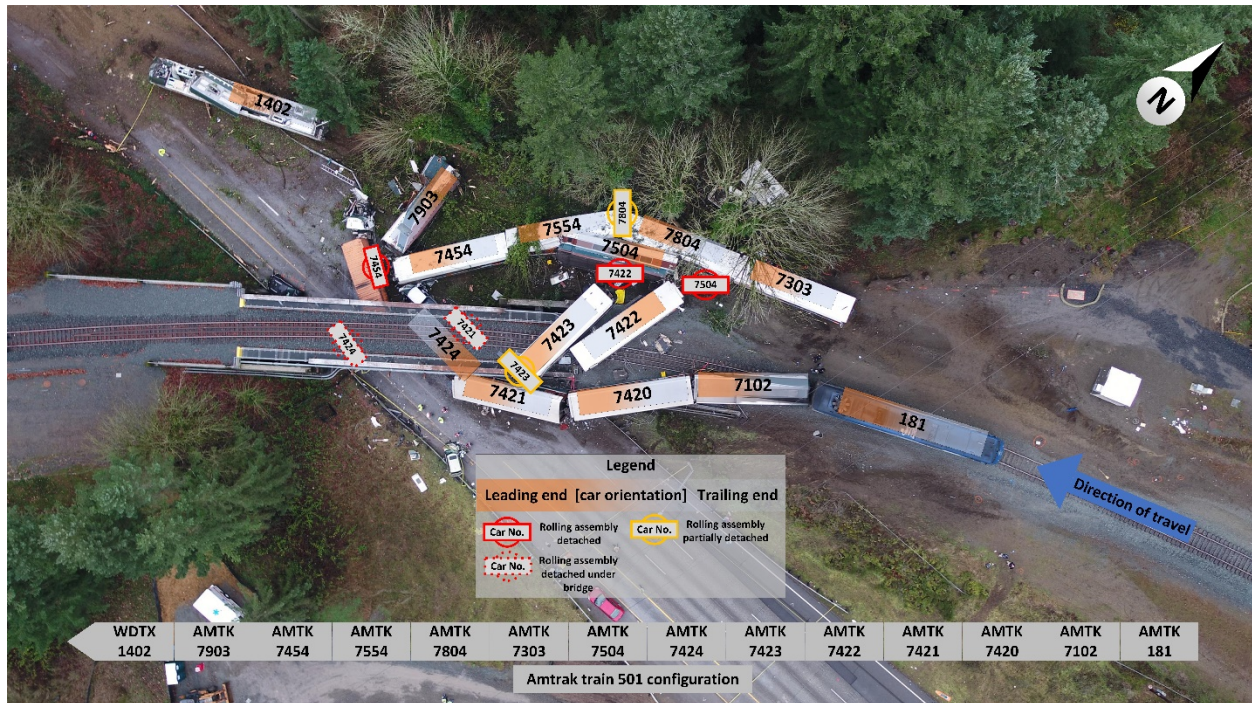
Figure 1. Post derailment schematic of train 501. (Photo WSP)

On December 18, 2017, Amtrak's "Mt. Adams" Train No. 501, was traveling southbound on the Lakewood subdivision in DuPont, Washington, which is a railroad corridor that has been upgraded in three separate phases by Sound Transit and the Washington State Department of Transportation (WSDOT). Amtrak train 501 consisting of 14-vehicles – a Siemens's Charger locomotive in the lead, a Talgo Series IV trainset of 12 semi-permanently coupled cars, and a GE P-42 locomotive in the rear, derailed on its entry into the curve at MP 19.86 immediately before a bridge that passed over the lanes of southbound Interstate 5 in DuPont, Washington.³ Event recorder data showed the train was traveling at about 80 miles per hour (mph) when it derailed. Figure 1 shows a post-derailment schematic of the train illustrating the resting location and orientation of the locomotive and cars, and the locations of the detached and partially detached rolling assemblies.

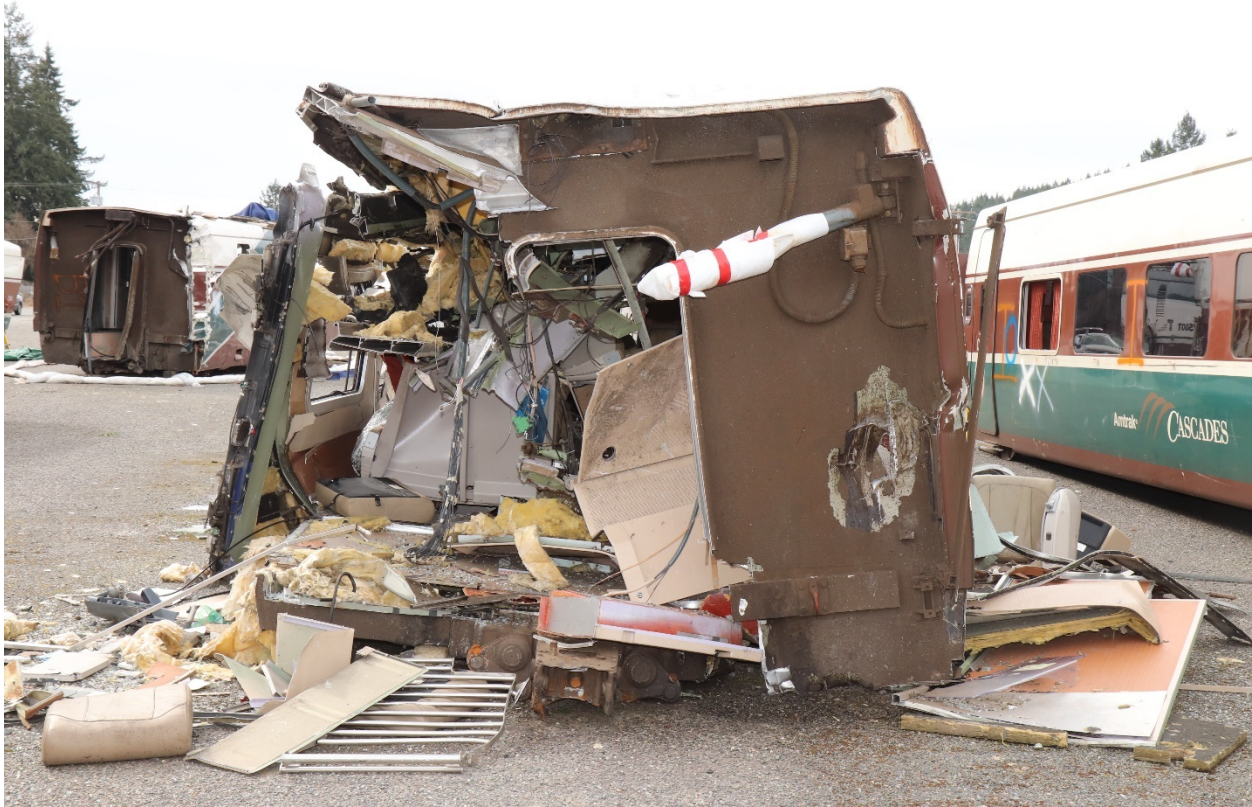
Figure 40. AMTK 7424 suspended end.

The end wall on suspended end of AMTK 7424 completely separated from the end frame. The structure exhibited signs of car to car impacts on the right side. The articulated connection [between AMTK 7423] fractured during the derailment. The weight bearer bars were fractured at the base. Both lower guidance bars were overstressed and fractured.

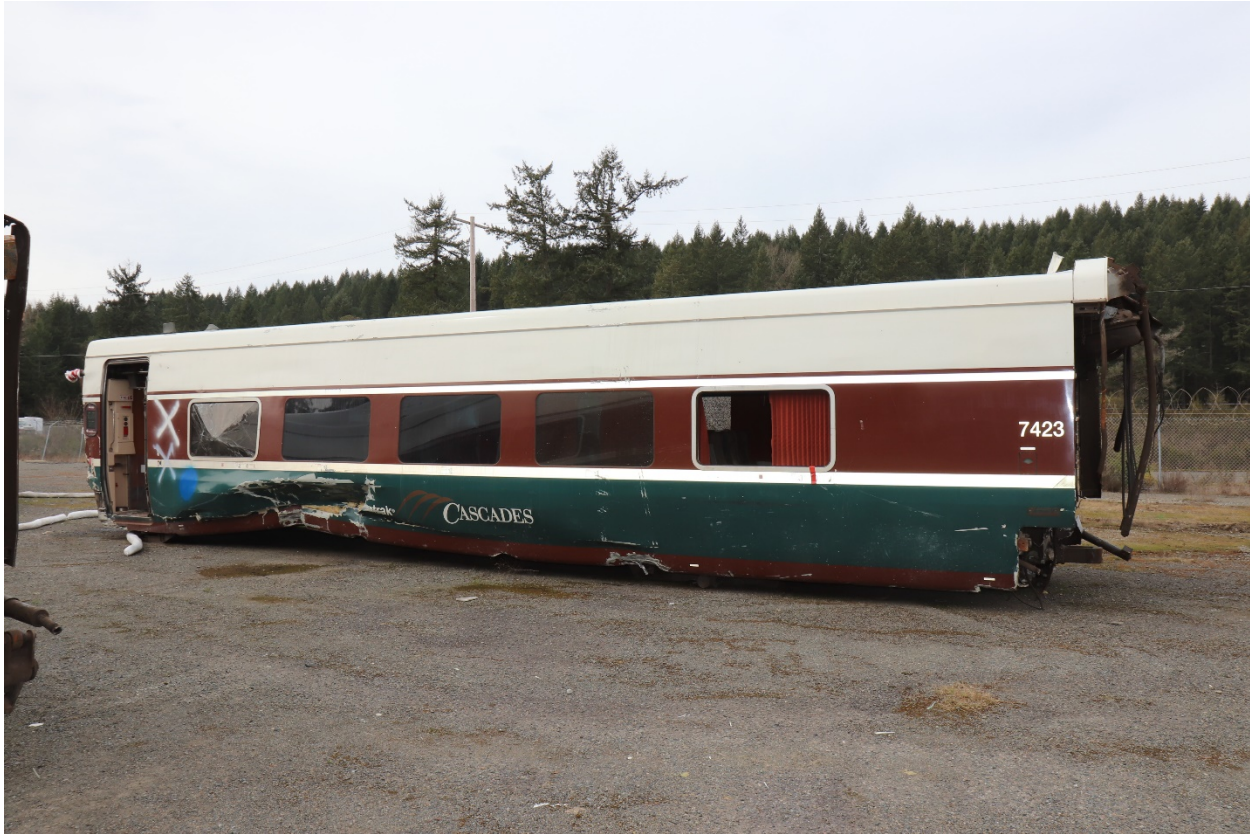
Figure 41. AMTK 7423 Right side.

The right-side wall exhibited a gouge 74-inches long, 12-inches tall, and 20-inches deep in the area near the side passenger door. At this location the interior floor rose approximately 12-inches resulting in a small loss of occupied space. One side passenger window was not in place during this examination apparently removed during the passenger evacuation.

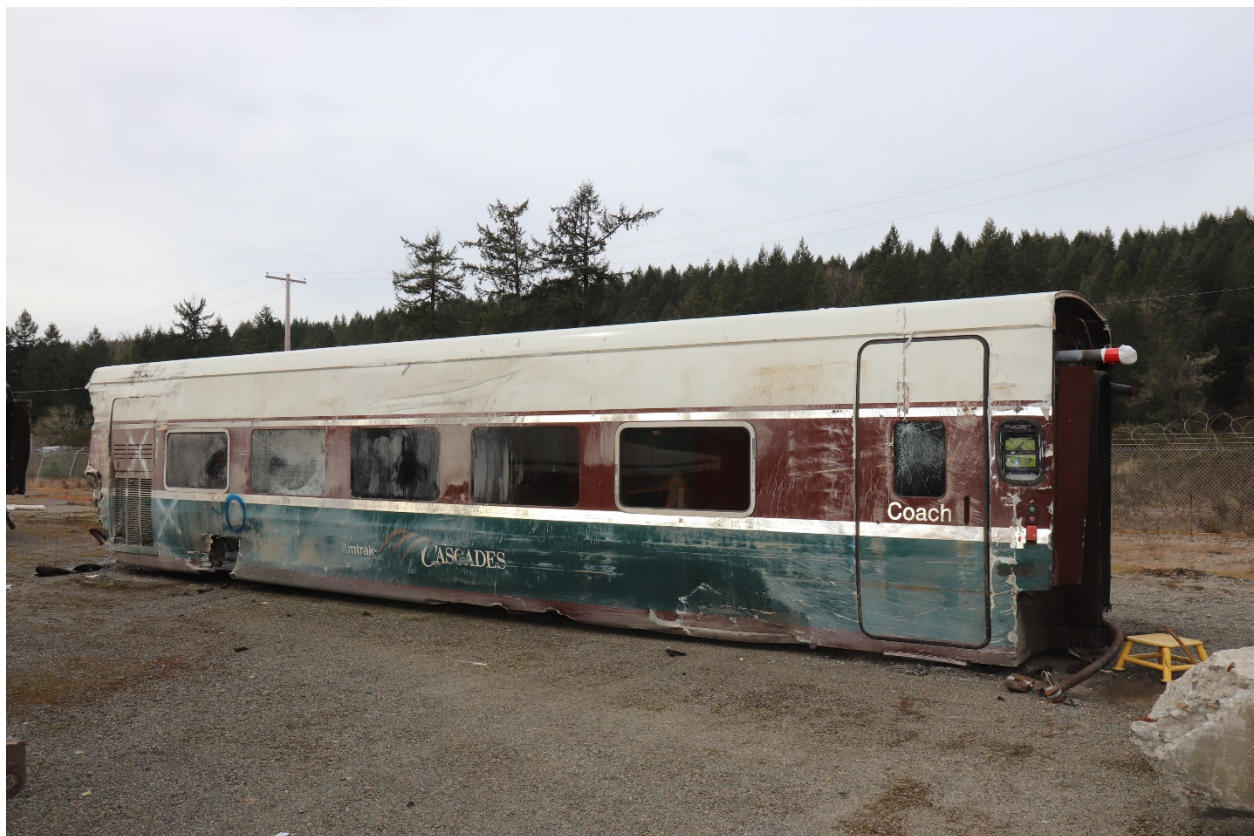
Figure 42. AMTK 7422 Left side.

The left side wall of AMTK 7422 was scraped and abraded along the full length of the car. The side wall was deformed inward near the side passenger door and the structure was compromised below the passenger windows at a location 12-feet from the supported end of the car. All passenger windows were in place; one window was shattered.

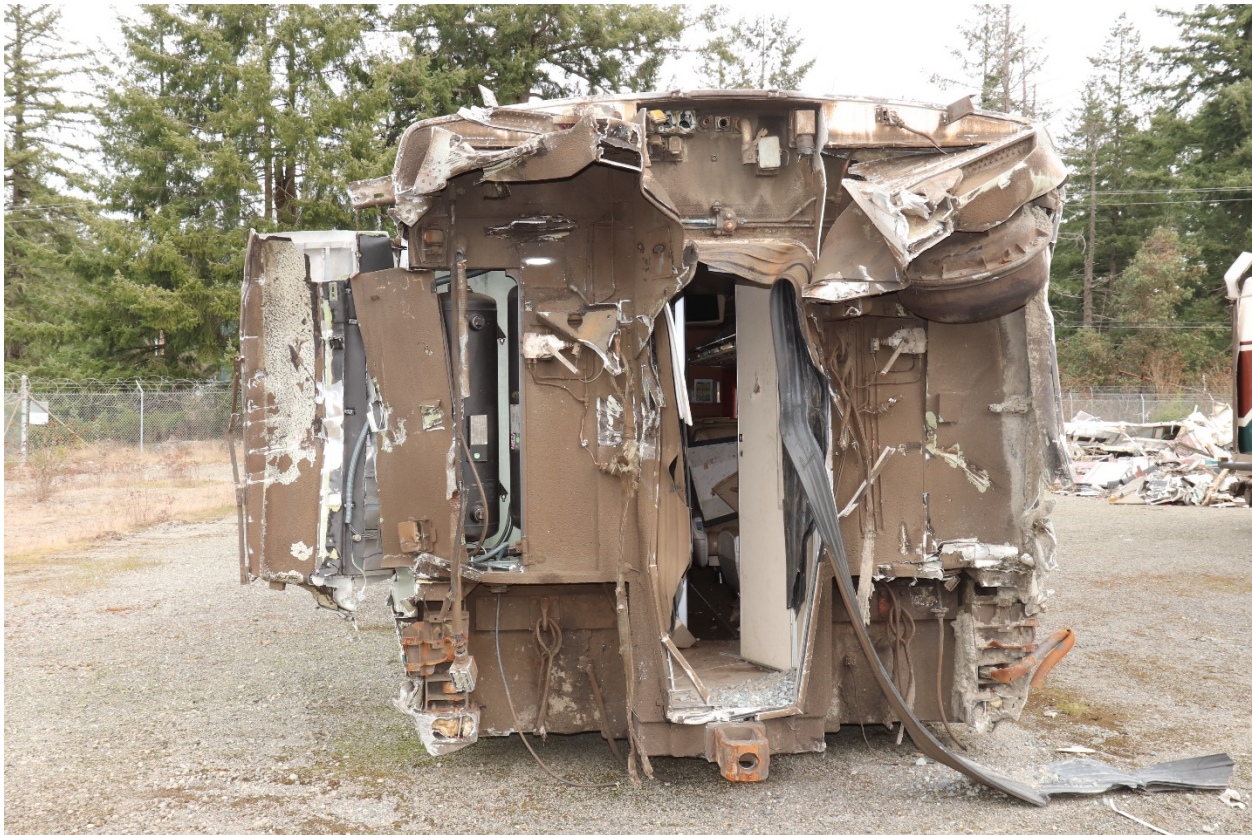
Figure 43. AMTK 7422 Supported end.

The supported end tower supports were severely deformed and sheared from the end wall. The end wall showed indications of car to car contact. The weight bearer bar mounts failed on both

sides. Both primary rolling assembly retention cables, upper and lower safety straps were broken. The upper guidance bars were deformed, overstressed and fractured. The rolling assembly from AMTK 7422 detached during the derailment. (The rolling assembly was located adjacent and partially inside 7504.) The articulated connection [between AMTK 7423] fractured during the derailment.

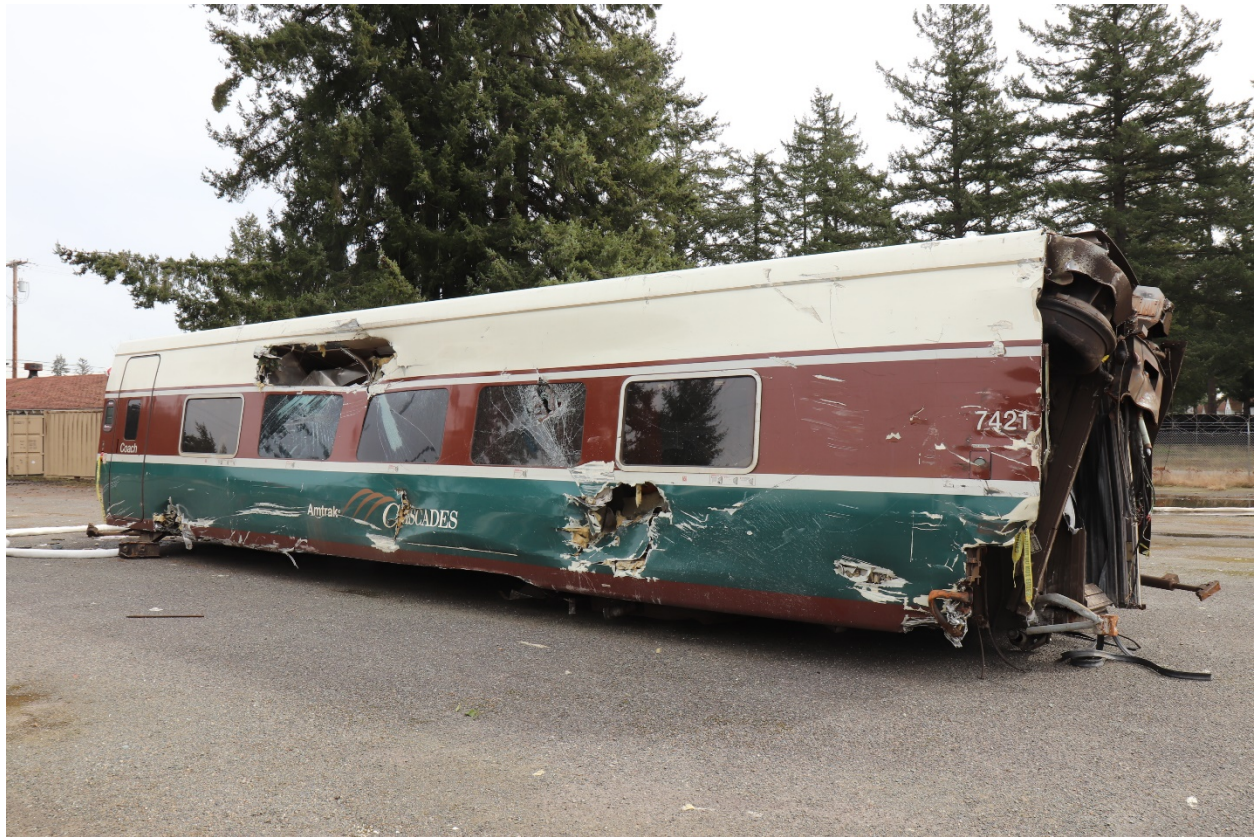
Figure 44. AMTK 7421 Right side.

The right side of AMTK 7421 exhibited several indications of impacts to the side wall of the car. Two of the impacts compromised the structure. One was located below the passenger

windows about 12-feet from the supported end of the car. The damaged measured about 3-feet in length and 2-feet high. The maximum depth of the damage was measured to be about 12-inches. The other impact that compromised the side wall structure was about 30-feet from the supported end above the passenger windows. The damage measured about 12-feet in length and 2-feet high. This damage was consistent with the resting position of the car after the derailment wherein the left wheel of the rolling assembly from AMTK 7423 collided with the side wall of AMTK 7421. All passenger windows were in place, two were shattered, one was punctured.

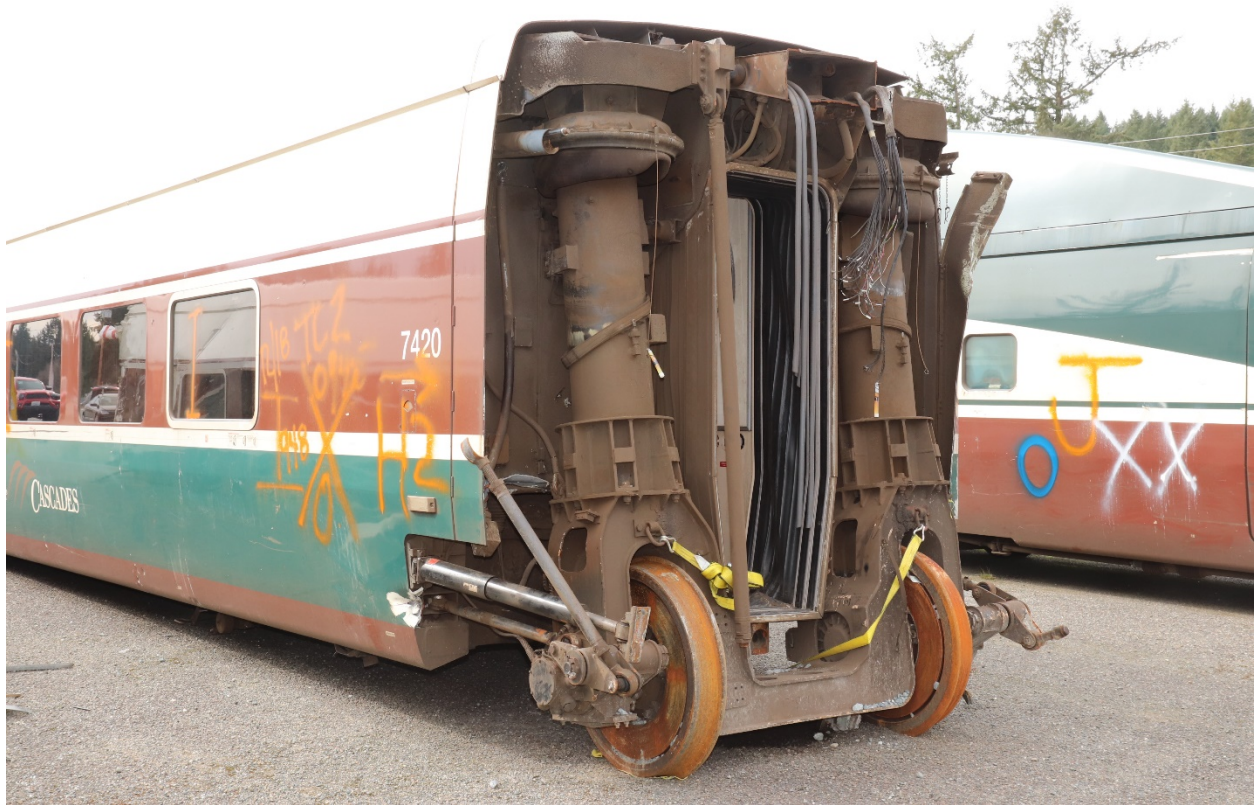
Figure 46. AMTK 7420 Supported end and right side.

The left side weight bearer bar mounting point was overloaded and sheared. The right-side mounting point remained intact but the bar was fractured at its end. The articulated connection was fractured between AMTK 7421.

The rolling assembly of AMTK 7420 remained attached during the derailment. The left main rolling assembly retaining cable broke. All other rolling assembly retention straps and cable were intact. The right side upper guidance bar remained in place the left was deformed slightly but intact. The left side lower guidance bar was overloaded and fractured at the opposing car connection point (AMTK 7421). The lower left guidance bar appeared to have fractured at the bell crank.

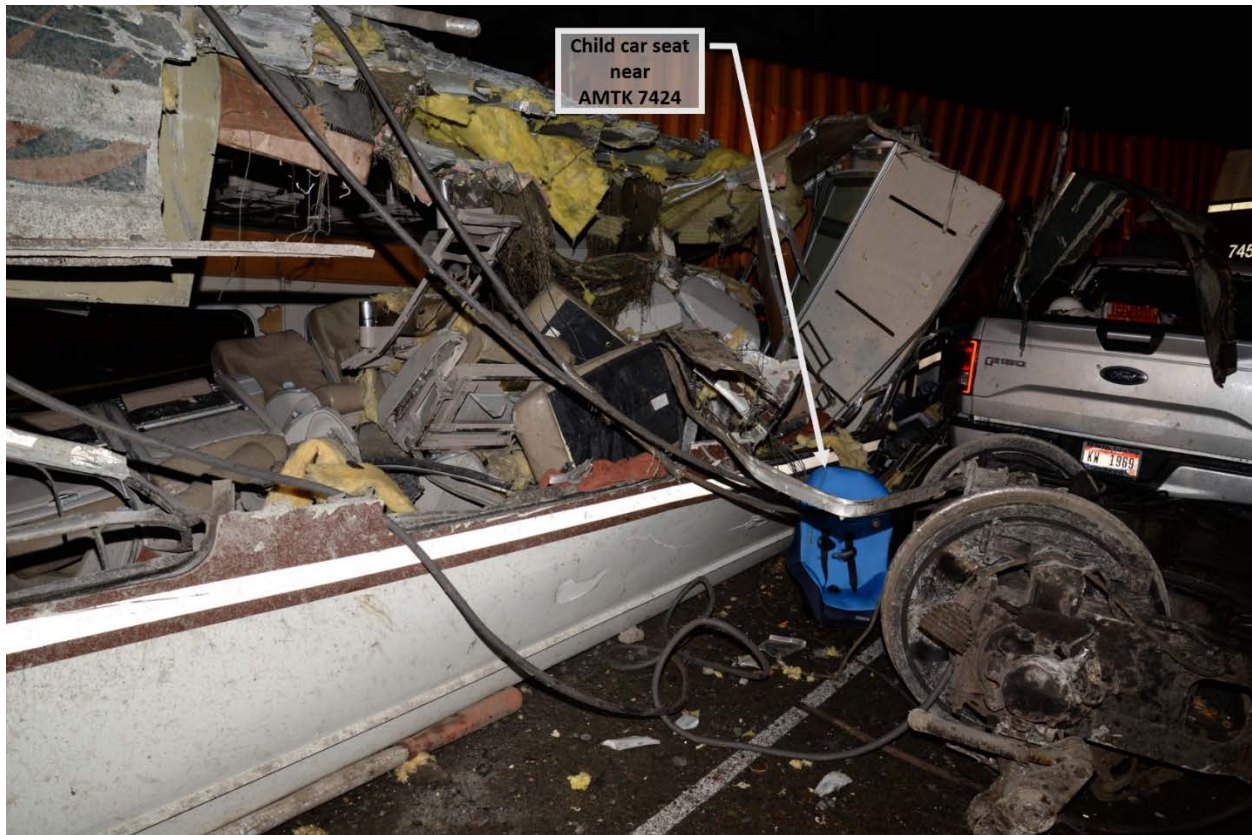
In one instance, a family boarded Amtrak 501 and sat in AMTK 7421. The family was traveling with an infant in a car seat. The parents reported that they were unaware that the train would not have securement straps necessary to belt the car seat into one of the seats in the car. Subsequently, the car seat containing the child was placed on top of a table during the journey. Just prior to the derailment; the father reported that he removed the child from the car seat and entered the lavatory. The car seat was left on top of the table. During the derailment, the unrestrained car seat was ejected out of AMTK 7421. The car seat was recovered outside near AMTK 7424 near a disconnected truck assembly.

Figure 55. Child car seat near AMTK 7424. (Photo FBI)

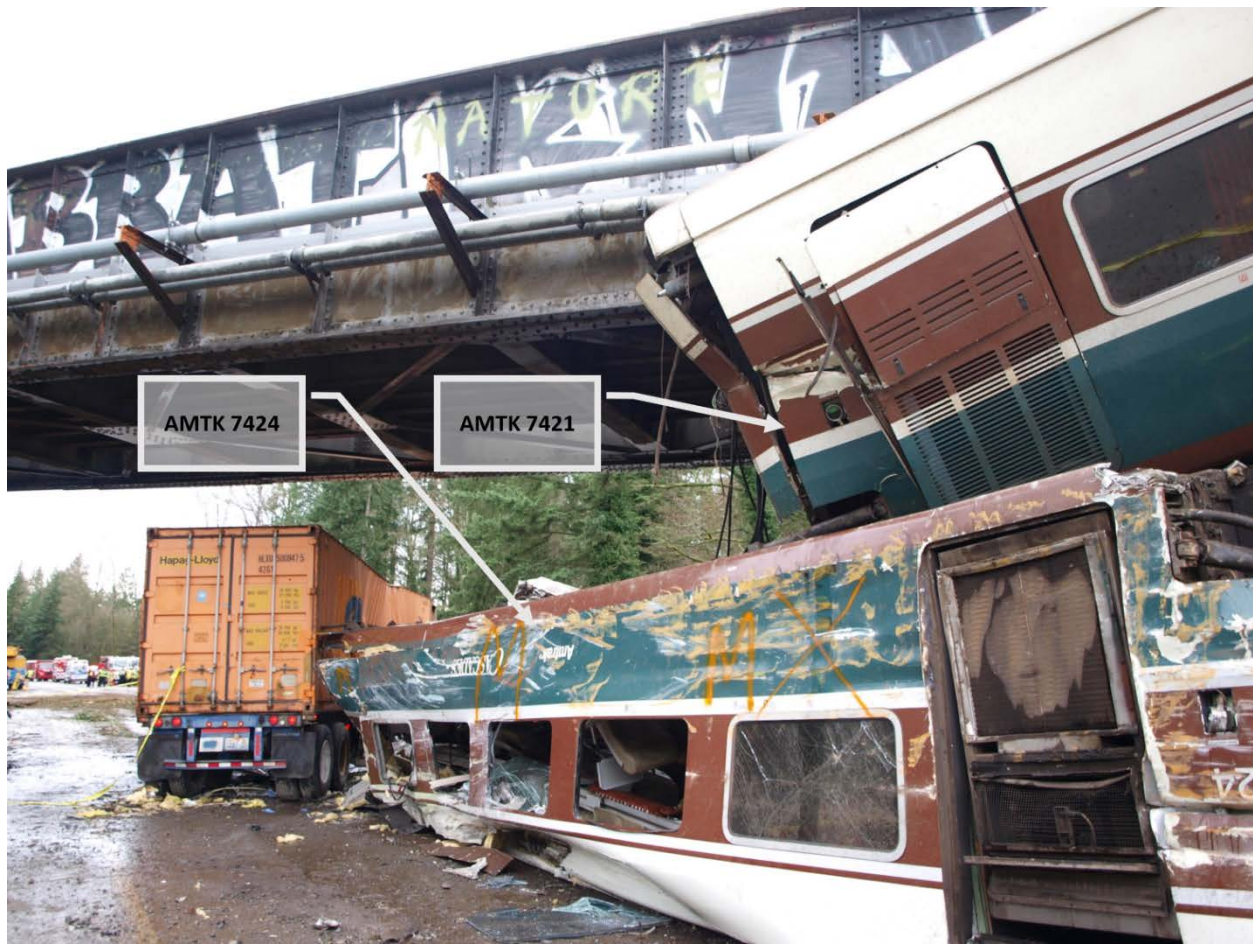
As a result of the derailment, AMTK 7421 came to rest hanging from the overpass and resting on top of AMTK 7424. The de-coupling of AMTK 7421 from its lead car, AMTK 7422, left an opening at the lowest point of the car, where it had been previously coupled. A female passenger sitting near the front of that car was thrown from her seat and partially ejected through the opening.

Figure 56. AMTK 7421 resting on AMTK 7424. (Photo WSP)

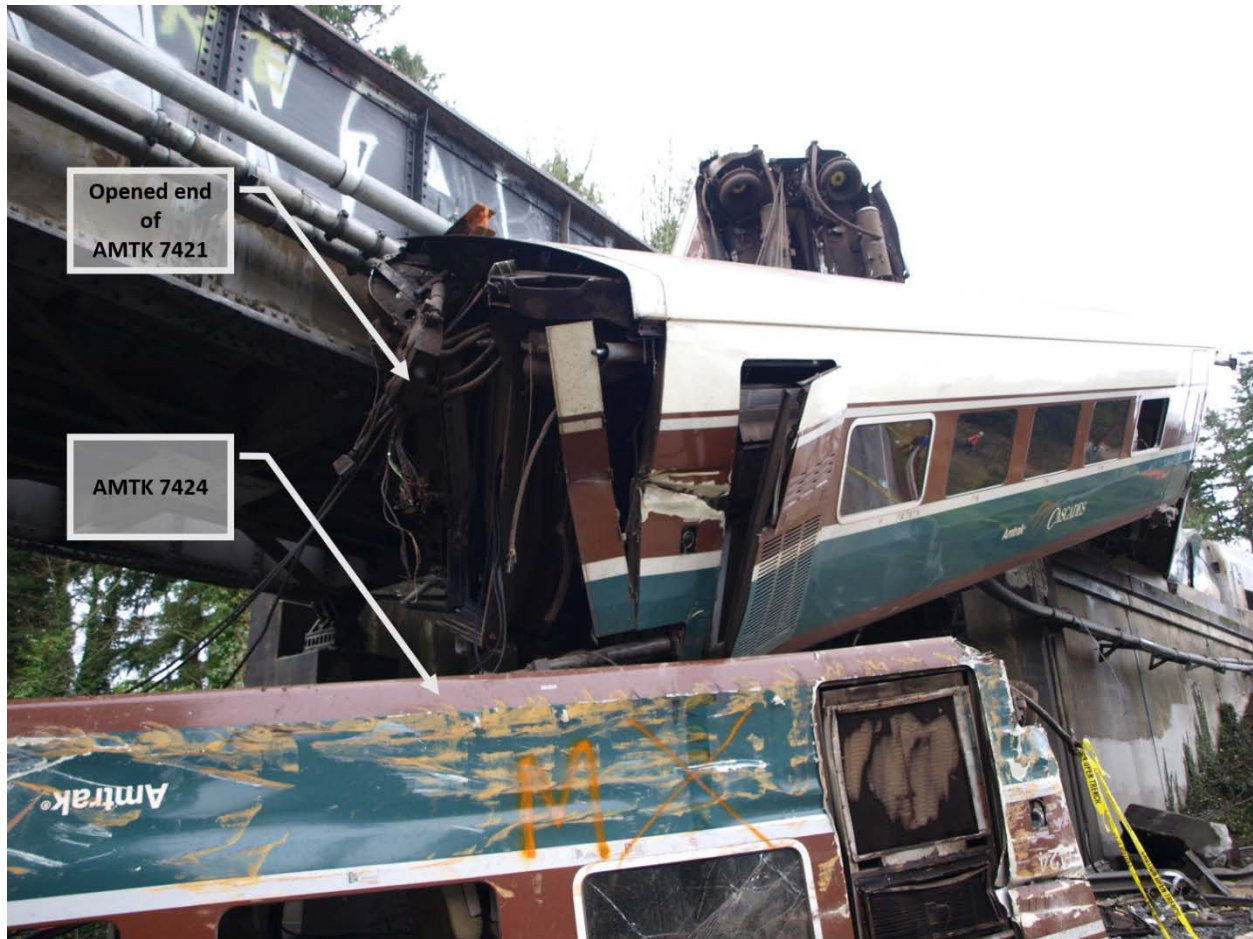
Figure 57. Open end of AMTK 7421. (Photo WSP)

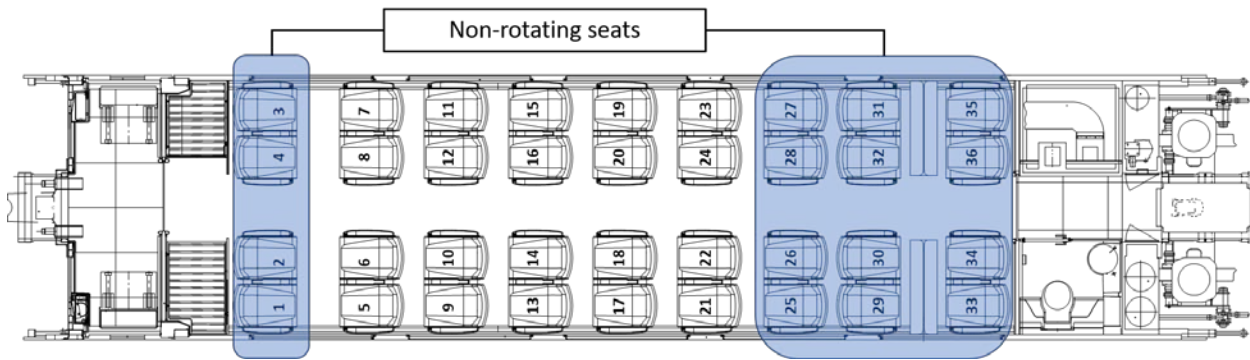
Post-crash interviews revealed that several passengers in AMTK 7423 were injured when three rows of seats started to rotate. Seat numbers 1, 2, 5, 6, 9 and 10.

Figure 58. Coach class seating layout showing rotating and non-rotating seats.

One passenger was struck in the head with enough force that it threw her into the window which she shattered when her face contacted the window. The seat corner of seat 2, which is not designed to rotate, contacted the rear bulkhead of the car, shattering the glass partition, directly behind the seat. A post-crash examination of AMTK 7423 revealed that during the derailment; the metal railing on the southside walkway on the overpass penetrated the lower portion of the car's sidewall. This resulted in the displacement of the interior sidewall. The three rows of seats were displaced laterally causing the seats to rotate. Figure 59 shows the intrusion by the metal railing into the car, and shows the displacement of seats caused by the intrusion.

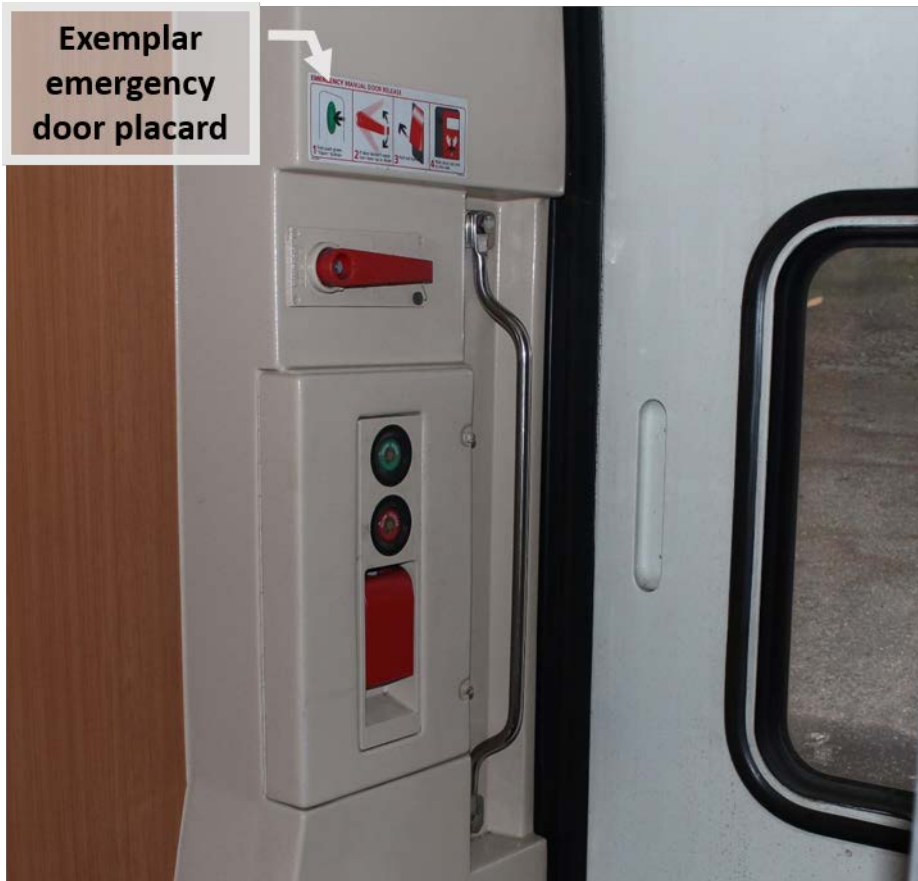
Another issue found with the lever involved the wire ties Talgo used to secure the lever to prevent accidental or deliberate tampering. In one case, the wire tie increased the difficulty in actuating the lever. Investigators had to use both hands and lean against the handle with their full weight to break the wire and move the lever.

In AMTK 7423, two passengers reported that they had attempted to exit the train after the derailment but could not get either of the exterior doors to open. An examination of the rail car revealed that whereas evidence was present to indicate that someone had attempted to open the door; it was clear that not all the proper steps to open the door were performed. The instructional placard was present but did not possess the required photo luminesce by regulation. The derailment occurred prior to sun up.

Figure 64. Exemplar emergency door showing instruction placard.

- Replace the emergency door opening instruction signs with ones compliant with the current HPPL requirement
- Replace the retroreflective border around the manual release levers and handles with compliant HPPL material
- Increase the illumination in the vestibule to assure the above material is sufficiently charged.

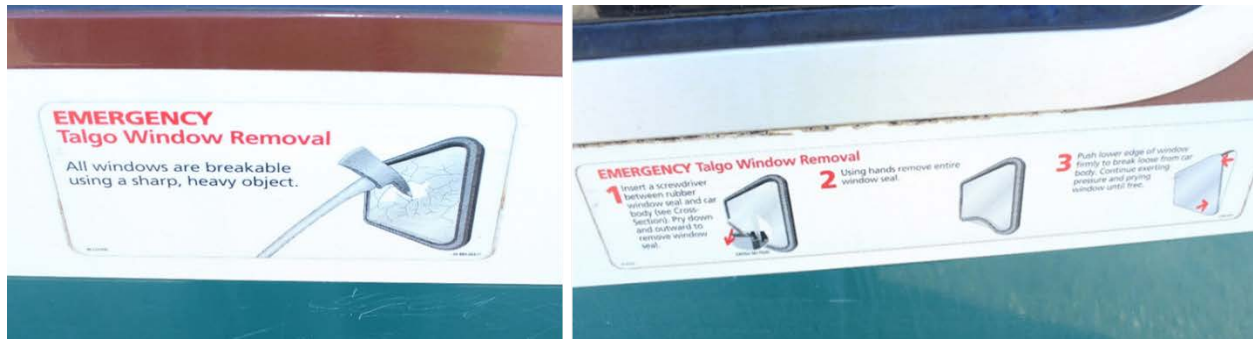
The exterior windows on each car had been marked with a decal indicating the proper way to use the window in an emergency. The car windows were found to function as designed. However, several of the passengers, bystanders and members of the fire department reported that the multiple window markings were confusing. The instruction provided to gain access through one window was not the same as the instructions provided to gain access to the adjacent window. In several instances, individuals were attempting to gain access through a window incorrectly, delaying access to the interior of the car and the rescue effort.

Figure 65 illustrates the decals found on the exterior of the rail car near windows on the Talgo cars. Instructions to correctly gain access are for the side passenger windows only. Figure 65

also shows the instructions for the emergency windows located at the first and last windows on each side of the cars.

Figure 65. Exterior emergency window removal instructions.
